Version No: 01 Issue Date: 13/03/2015 Portfolio: Water Quality	Horizons Regional Council	Section No: 9.30 Page: 1 of 2
horizons regional council

Hydrology Operations Manual

WTW firmware upgrade

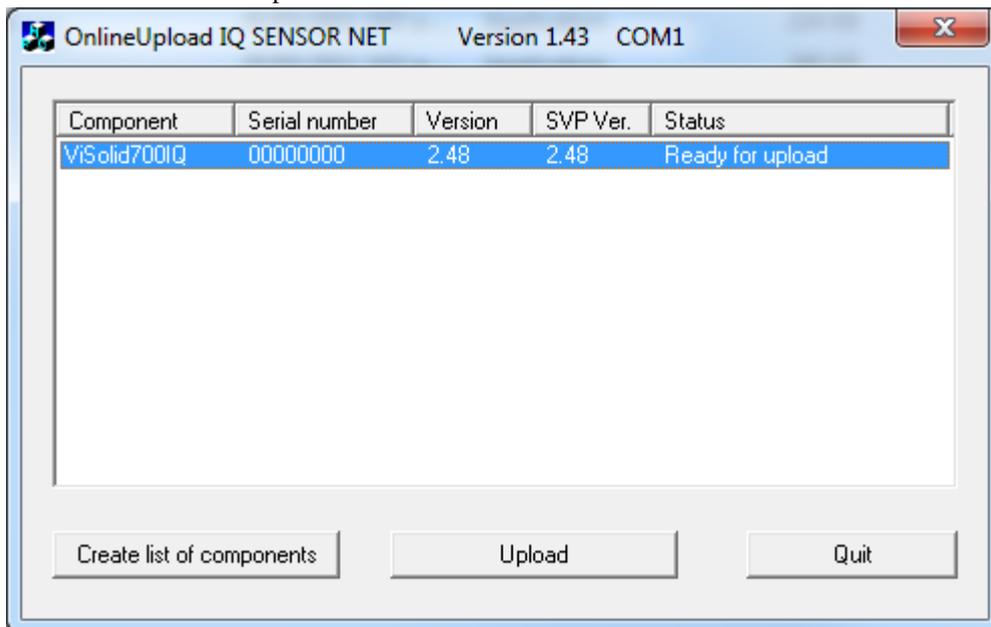
- 1) Run the application: “C:\25393_IQProdServicePack\IQS_UpdatePack_L1\0_OnlineUpdate\OnlineUpload”
- 2) Press “Create list of components”

- 3) Highlight the sensor and press “Upload”
- 4) Select the software (same as for alternative option below):

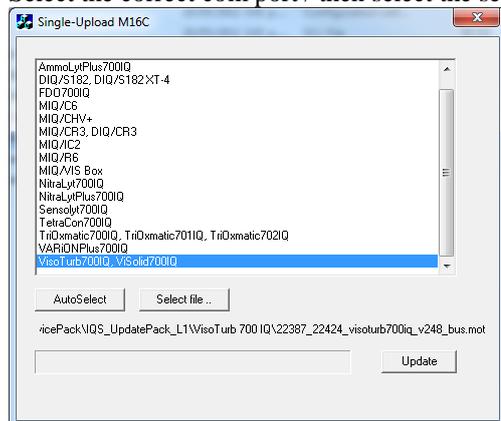
Select the correct com port / then select the sensor:

Can try the Auto select firmware option, or choose the firmware manually.

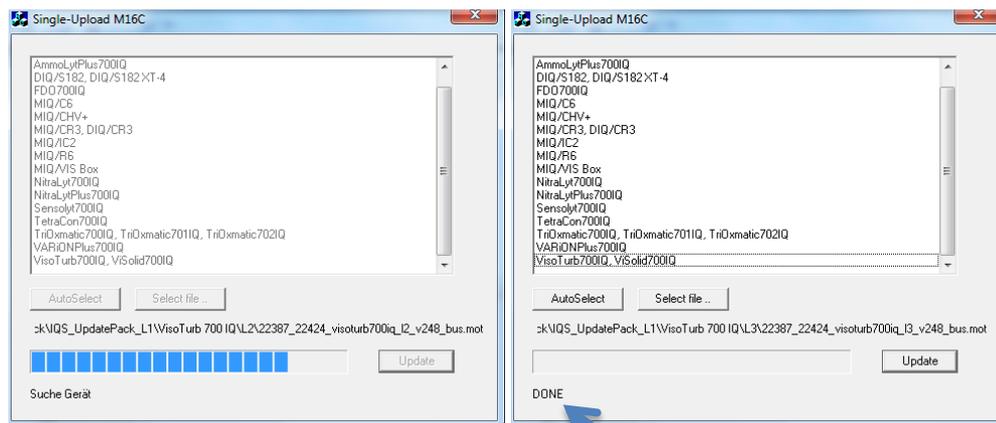
- 5) Select file from “C:\25393_IQProdServicePack\IQS_UpdatePack_L1\”
- 6) Eg turbidity: “C:\25393_IQProdServicePack\IQS_UpdatePack_L1\VisoTurb 700 IQ\L3\22387_22424_visoturb700iq_l3_v248_bus.mot”
- 7) Select the device to update:

Sensor should be working with new firmware. If not refer to service agent.
